# Asbestos Survey Report

Keresley Newland Primary School  
 Grove Lane  
 Coventry  
 CV7 8JZ

Report No: J065273

Issue No: 1  
 Issue date: 9 Aug 2022  
 UPRN: N/A

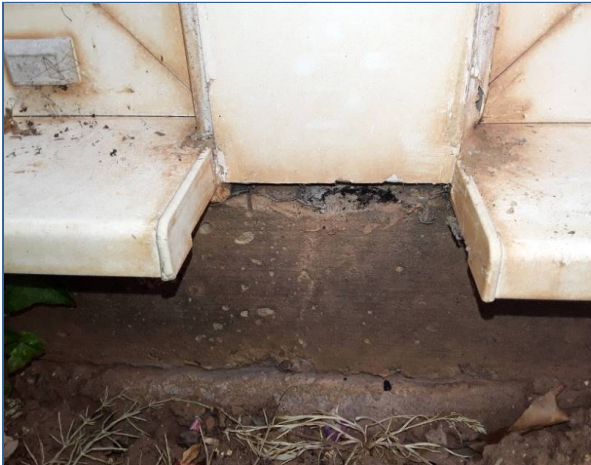
Room Code	Ref no.	Designation/Block	Floor	Sample I.D.	
E.01	095	Commercial	External	EF022661	
Location	Description	Position	Quantity		
External	Damp proof course	To underside of building	Throughout		
Material Assessment Algorithm					
A-Product Type	B-Extent of Damage	C-Surface Treatment	D-Asbestos Type	Material Score (A+B+C+D)	Potential to Release Fibres
Well Bound Material (1)	Good Condition (0)	Composites, plastics, resins, vinyl (0)	Chrysotile (1)	2	Very Low
Accessibility	Usually inaccessible or unlikely to be disturbed	Action Priority	Longer term		
Photo Ref:	95	Discussion & Recommended Action (in accordance with CAR 2012)

Management Action				
	No action required. Inspect at regular intervals and consider labelling if not already labelled				
	Additional Comments				
Not applicable					
Who can work with / remove this material	Non-Licensed Materials	Recommended re-inspection in:	12 months

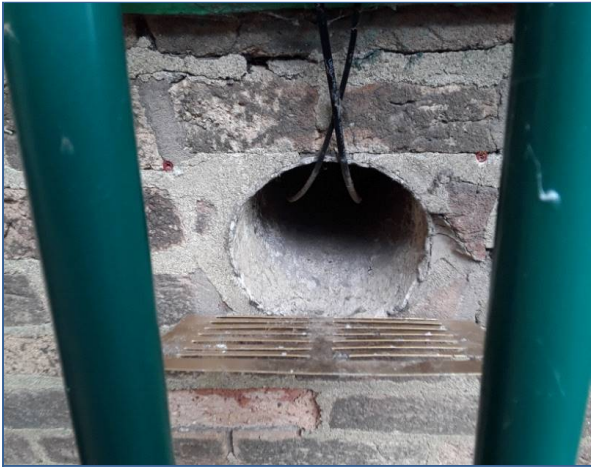
Room Code	Ref no.	Designation/Block	Floor	Sample I.D.	
E.01	098	Commercial	External	As EF022656	
Location	Description	Position	Quantity		
External	Vent pipe(redundant)	Within wall behind gold grate above plant room	<1lm		
Material Assessment Algorithm					
A-Product Type	B-Extent of Damage	C-Surface Treatment	D-Asbestos Type	Material Score (A+B+C+D)	Potential to Release Fibres
Asbestos Cement (1)	Low Damage (1)	Cement, coatings, sealed AIB, insulation, sprays etc. (1)	Chrysotile (1)	4	Very Low
Accessibility	Usually inaccessible or unlikely to be disturbed	Action Priority	Longer term		
Photo Ref:	98	Discussion & Recommended Action (in accordance with CAR 2012)

Management Action				
	No action required. Inspect at regular intervals and consider labelling if not already labelled				
	Additional Comments				
Not applicable					
Who can work with / remove this material	Non-Licensed Materials	Recommended re-inspection in:	12 months

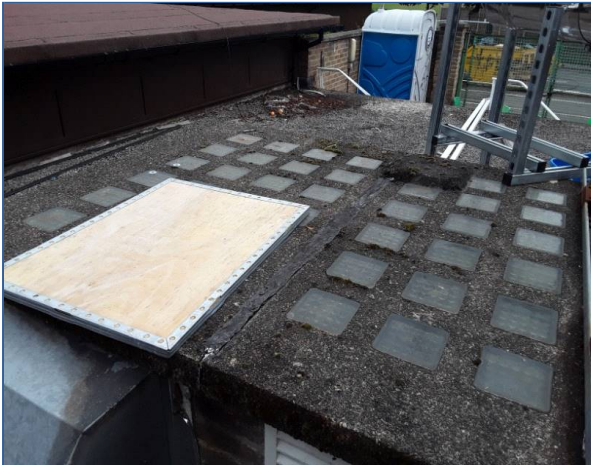
Room Code	Ref no.	Designation/Block	Floor	Sample I.D.	
E.01	100	Commercial	External	EF022665	
Location	Description	Position	Quantity		
External	Putty	To joint of concrete blocks	2lm		
Material Assessment Algorithm					
A-Product Type	B-Extent of Damage	C-Surface Treatment	D-Asbestos Type	Material Score (A+B+C+D)	Potential to Release Fibres
Well Bound Material (1)	Good Condition (0)	Composites, plastics, resins, vinyl (0)	Chrysotile (1)	2	Very Low
Accessibility	Usually inaccessible or unlikely to be disturbed	Action Priority	Longer term		
Photo Ref:	100	Discussion & Recommended Action (in accordance with CAR 2012)

Management Action				
	No action required. Inspect at regular intervals and consider labelling if not already labelled				
	Additional Comments				
Located above plant room where metal flue passes through. Asbestos found in brown putty only - brown wood is none asbestos					
Who can work with / remove this material	Non-Licensed Materials	Recommended re-inspection in:	12 months

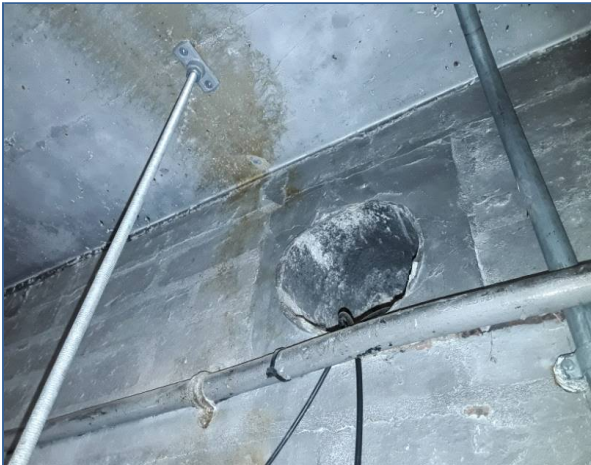
Room Code	Ref no.	Designation/Block	Floor	Sample I.D.	
Z1.01	088	Commercial	Z-Sub Level 1	EF022656	
Location	Description	Position	Quantity		
Plant Room	Vent pipe(redundant)	Extending through wall	<1lm		
Material Assessment Algorithm					
A-Product Type	B-Extent of Damage	C-Surface Treatment	D-Asbestos Type	Material Score (A+B+C+D)	Potential to Release Fibres
Asbestos Cement (1)	Low Damage (1)	Cement, coatings, sealed AIB, insulation, sprays etc. (1)	Chrysotile (1)	4	Very Low
Accessibility	Usually inaccessible or unlikely to be disturbed	Action Priority	Longer term		
Photo Ref:	88	Discussion & Recommended Action (in accordance with CAR 2012)

Management Action				
	No action required. Inspect at regular intervals and consider labelling if not already labelled				
	Additional Comments				
Not applicable					
Who can work with / remove this material	Non-Licensed Materials	Recommended re-inspection in:	12 months

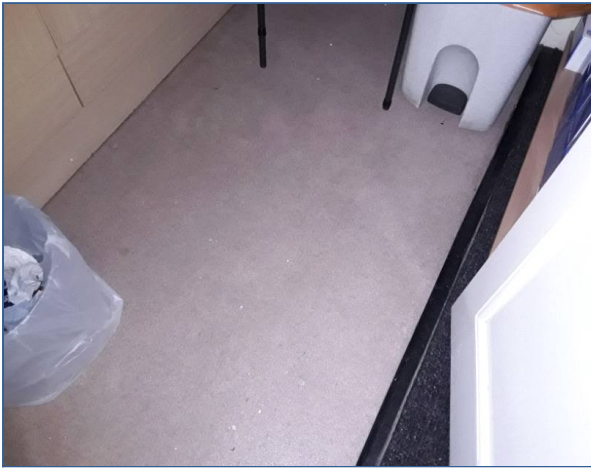
Room Code	Ref no.	Designation/Block	Floor	Sample I.D.	
G.13	012	Commercial	Gnd Floor	EF022643	
Location	Description	Position	Quantity		
Medical Room	Orange tiles with adhesive	Below carpet/vinyl to the floor	2m <sup>2</sup>		
Material Assessment Algorithm					
A-Product Type	B-Extent of Damage	C-Surface Treatment	D-Asbestos Type	Material Score (A+B+C+D)	Potential to Release Fibres
Reinforced Composite + Well Bound Material (1)	Good Condition (0)	Composites, plastics, resins, vinyl (0)	Chrysotile (1)	2	Very Low
Accessibility	Usually inaccessible or unlikely to be disturbed	Action Priority	Longer term		
Photo Ref:	12	Discussion & Recommended Action (in accordance with CAR 2012)

Management Action				
	No action required. Inspect at regular intervals and consider labelling if not already labelled				
	Additional Comments				
Not applicable					
Who can work with / remove this material	Non-Licensed Materials	Recommended re-inspection in:	12 months

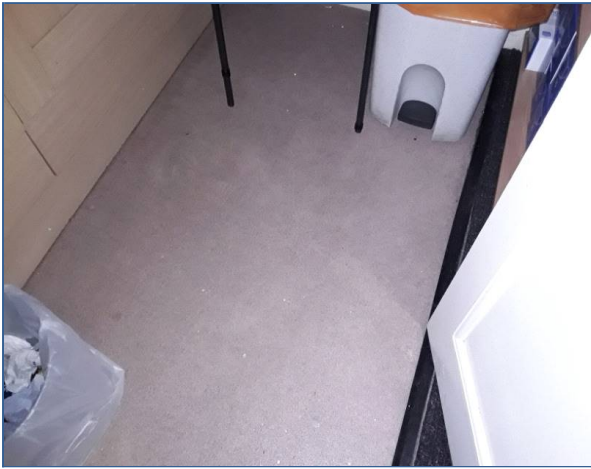
Room Code	Ref no.	Designation/Block	Floor	Sample I.D.	
G.13	013	Commercial	Gnd Floor	EF022644	
Location	Description	Position	Quantity		
Medical Room	Green tiles with adhesive	Below carpet/vinyl to the floor	2m <sup>2</sup>		
Material Assessment Algorithm					
A-Product Type	B-Extent of Damage	C-Surface Treatment	D-Asbestos Type	Material Score (A+B+C+D)	Potential to Release Fibres
Reinforced Composite + Well Bound Material (1)	Good Condition (0)	Composites, plastics, resins, vinyl (0)	Chrysotile (1)	2	Very Low
Accessibility	Usually inaccessible or unlikely to be disturbed	Action Priority	Longer term		
Photo Ref:	13	Discussion & Recommended Action (in accordance with CAR 2012)

Management Action				
	No action required. Inspect at regular intervals and consider labelling if not already labelled				
	Additional Comments				
Not applicable					
Who can work with / remove this material	Non-Licensed Materials	Recommended re-inspection in:	12 months

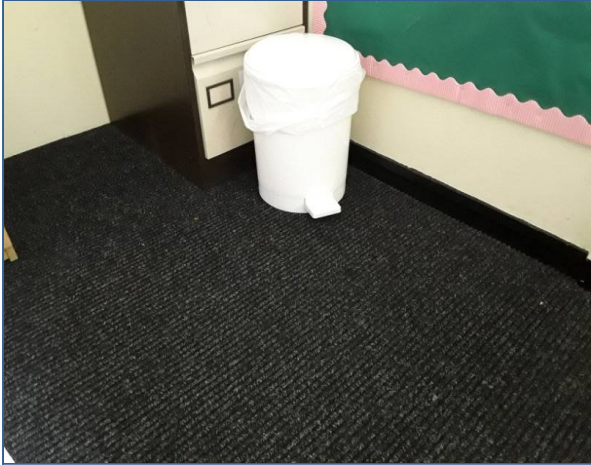
Room Code	Ref no.	Designation/Block	Floor	Sample I.D.	
G.14	014	Commercial	Gnd Floor	As EF022643	
Location	Description	Position	Quantity		
Meeting Room	Orange tiles with adhesive	Below carpet to the floor	4m <sup>2</sup>		
Material Assessment Algorithm					
A-Product Type	B-Extent of Damage	C-Surface Treatment	D-Asbestos Type	Material Score (A+B+C+D)	Potential to Release Fibres
Reinforced Composite + Well Bound Material (1)	Good Condition (0)	Composites, plastics, resins, vinyl (0)	Chrysotile (1)	2	Very Low
Accessibility	Usually inaccessible or unlikely to be disturbed	Action Priority	Longer term		
Photo Ref:	14	Discussion & Recommended Action (in accordance with CAR 2012)

Management Action				
	No action required. Inspect at regular intervals and consider labelling if not already labelled				
	Additional Comments				
Not applicable					
Who can work with / remove this material	Non-Licensed Materials	Recommended re-inspection in:	12 months

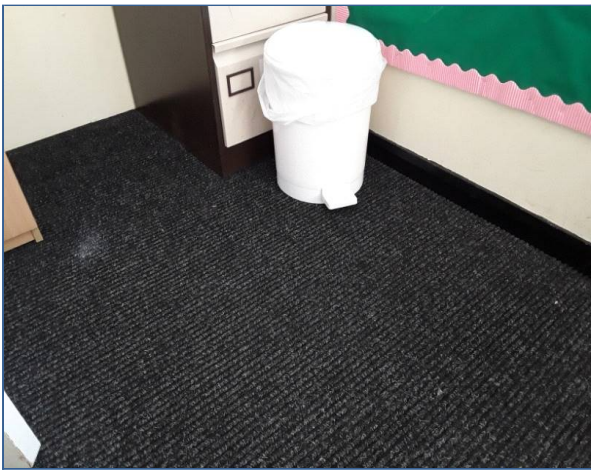
Room Code	Ref no.	Designation/Block	Floor	Sample I.D.	
G.14	015	Commercial	Gnd Floor	As EF022644	
Location	Description	Position	Quantity		
Meeting Room	Green tiles with adhesive	Below carpet to the floor	4m <sup>2</sup>		
Material Assessment Algorithm					
A-Product Type	B-Extent of Damage	C-Surface Treatment	D-Asbestos Type	Material Score (A+B+C+D)	Potential to Release Fibres
Reinforced Composite + Well Bound Material (1)	Good Condition (0)	Composites, plastics, resins, vinyl (0)	Chrysotile (1)	2	Very Low
Accessibility	Usually inaccessible or unlikely to be disturbed	Action Priority	Longer term		
Photo Ref:	15	Discussion & Recommended Action (in accordance with CAR 2012)

Management Action				
	No action required. Inspect at regular intervals and consider labelling if not already labelled				
	Additional Comments				
Not applicable					
Who can work with / remove this material	Non-Licensed Materials	Recommended re-inspection in:	12 months

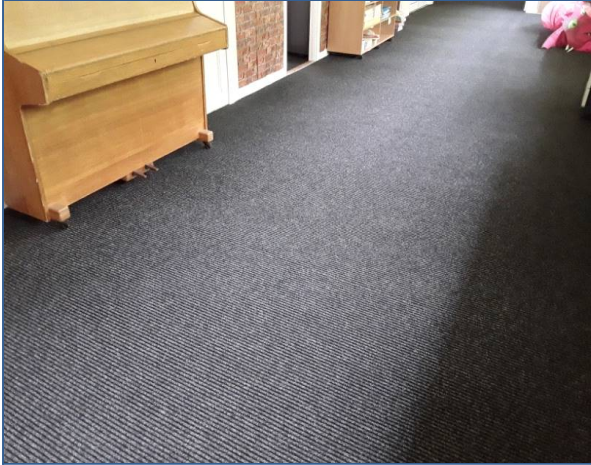
Room Code	Ref no.	Designation/Block	Floor	Sample I.D.	
G.16	017	Commercial	Gnd Floor	As EF022643	
Location	Description	Position	Quantity		
Corridor	Orange tiles with adhesive	Below carpet to the floor	30m <sup>2</sup>		
Material Assessment Algorithm					
A-Product Type	B-Extent of Damage	C-Surface Treatment	D-Asbestos Type	Material Score (A+B+C+D)	Potential to Release Fibres
Reinforced Composite + Well Bound Material (1)	Good Condition (0)	Composites, plastics, resins, vinyl (0)	Chrysotile (1)	2	Very Low
Accessibility	Usually inaccessible or unlikely to be disturbed	Action Priority	Longer term		
Photo Ref:	17	Discussion & Recommended Action (in accordance with CAR 2012)

Management Action				
	No action required. Inspect at regular intervals and consider labelling if not already labelled				
	Additional Comments				
Not applicable					
Who can work with / remove this material	Non-Licensed Materials	Recommended re-inspection in:	12 months

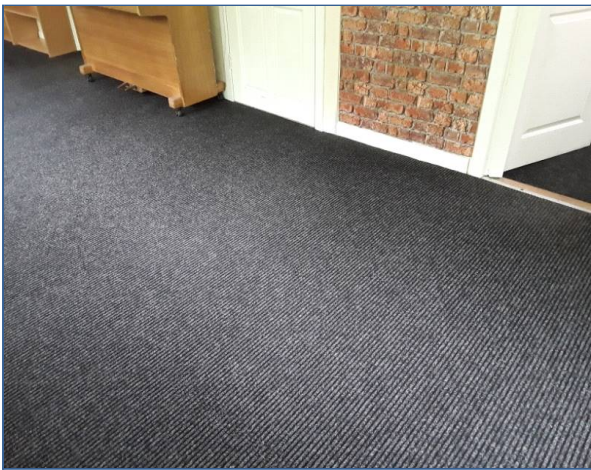
Room Code	Ref no.	Designation/Block	Floor	Sample I.D.	
G.16	018	Commercial	Gnd Floor	As EF022644	
Location	Description	Position	Quantity		
Corridor	Green tiles with adhesive	Below carpet to the floor	30m <sup>2</sup>		
Material Assessment Algorithm					
A-Product Type	B-Extent of Damage	C-Surface Treatment	D-Asbestos Type	Material Score (A+B+C+D)	Potential to Release Fibres
Reinforced Composite + Well Bound Material (1)	Good Condition (0)	Composites, plastics, resins, vinyl (0)	Chrysotile (1)	2	Very Low
Accessibility	Usually inaccessible or unlikely to be disturbed	Action Priority	Longer term		
Photo Ref:	18	Discussion & Recommended Action (in accordance with CAR 2012)

Management Action				
	No action required. Inspect at regular intervals and consider labelling if not already labelled				
	Additional Comments				
Not applicable					
Who can work with / remove this material	Non-Licensed Materials	Recommended re-inspection in:	12 months

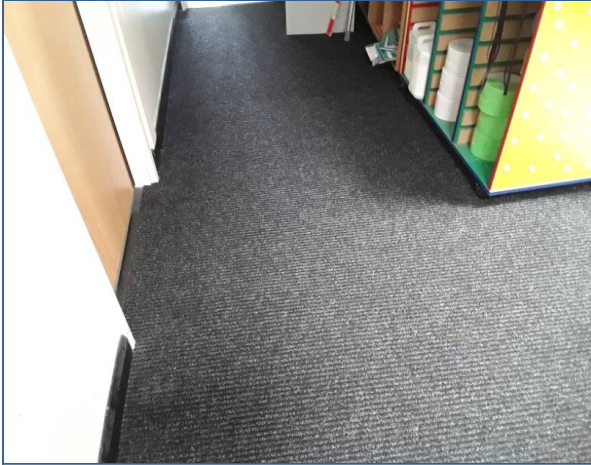
Room Code	Ref no.	Designation/Block	Floor	Sample I.D.	
G.24	025	Commercial	Gnd Floor	As EF022643	
Location	Description	Position	Quantity		
Corridor	Orange tiles with adhesive	Below carpet to the floor	8m <sup>2</sup>		
Material Assessment Algorithm					
A-Product Type	B-Extent of Damage	C-Surface Treatment	D-Asbestos Type	Material Score (A+B+C+D)	Potential to Release Fibres
Reinforced Composite + Well Bound Material (1)	Good Condition (0)	Composites, plastics, resins, vinyl (0)	Chrysotile (1)	2	Very Low
Accessibility	Usually inaccessible or unlikely to be disturbed	Action Priority	Longer term		
Photo Ref:	25	Discussion & Recommended Action (in accordance with CAR 2012)

Management Action				
	No action required. Inspect at regular intervals and consider labelling if not already labelled				
	Additional Comments				
Not applicable					
Who can work with / remove this material	Non-Licensed Materials	Recommended re-inspection in:	12 months

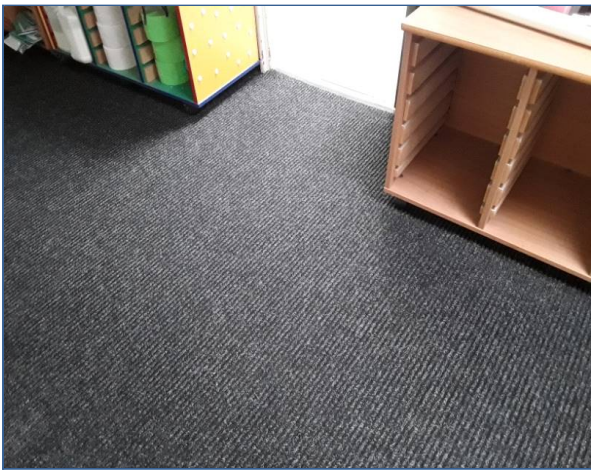
Room Code	Ref no.	Designation/Block	Floor	Sample I.D.	
G.24	026	Commercial	Gnd Floor	As EF022644	
Location	Description	Position	Quantity		
Corridor	Green tiles with adhesive	Below carpet to the floor	8m <sup>2</sup>		
Material Assessment Algorithm					
A-Product Type	B-Extent of Damage	C-Surface Treatment	D-Asbestos Type	Material Score (A+B+C+D)	Potential to Release Fibres
Reinforced Composite + Well Bound Material (1)	Good Condition (0)	Composites, plastics, resins, vinyl (0)	Chrysotile (1)	2	Very Low
Accessibility	Usually inaccessible or unlikely to be disturbed	Action Priority	Longer term		
Photo Ref:	26	Discussion & Recommended Action (in accordance with CAR 2012)

Management Action				
	No action required. Inspect at regular intervals and consider labelling if not already labelled				
	Additional Comments				
Not applicable					
Who can work with / remove this material	Non-Licensed Materials	Recommended re-inspection in:	12 months

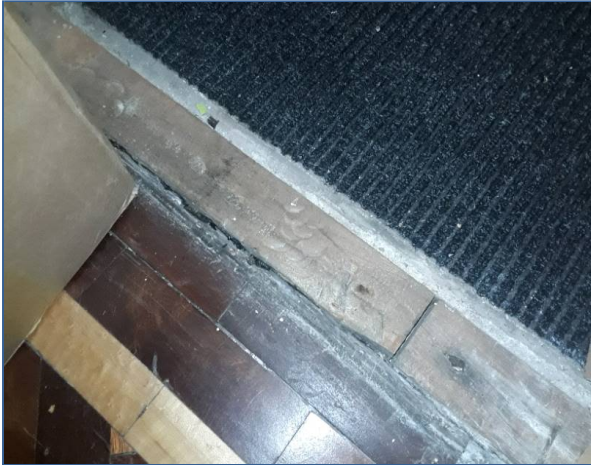
Room Code	Ref no.	Designation/Block	Floor	Sample I.D.	
G.32	057	Commercial	Gnd Floor	EF022649	
Location	Description	Position	Quantity		
Store	Damp proof membrane	To floor by door below wood beam	11m		
Material Assessment Algorithm					
A-Product Type	B-Extent of Damage	C-Surface Treatment	D-Asbestos Type	Material Score (A+B+C+D)	Potential to Release Fibres
Well Bound Material (1)	Good Condition (0)	Composites, plastics, resins, vinyl (0)	Chrysotile (1)	2	Very Low
Accessibility	Usually inaccessible or unlikely to be disturbed	Action Priority	Longer term		
Photo Ref:	57	Discussion & Recommended Action (in accordance with CAR 2012)

Management Action				
	No action required. Inspect at regular intervals and consider labelling if not already labelled				
	Additional Comments				
Not applicable					
Who can work with / remove this material	Non-Licensed Materials	Recommended re-inspection in:	12 months

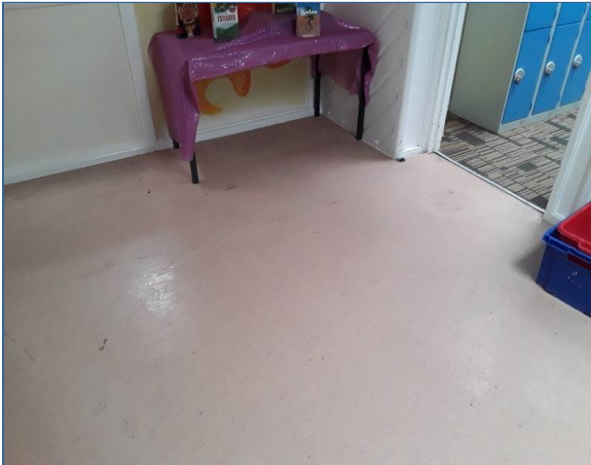
Room Code	Ref no.	Designation/Block	Floor	Sample I.D.	
G.74	078	Commercial	Gnd Floor	EF022652	
Location	Description	Position	Quantity		
Circulation	Screed with adhesive	Below vinyl to the floor	12m <sup>2</sup>		
Material Assessment Algorithm					
A-Product Type	B-Extent of Damage	C-Surface Treatment	D-Asbestos Type	Material Score (A+B+C+D)	Potential to Release Fibres
Well Bound Material (1)	Low Damage (1)	Composites, plastics, resins, vinyl (0)	Chrysotile (1)	3	Very Low
Accessibility	Usually inaccessible or unlikely to be disturbed	Action Priority	Longer term		
Photo Ref:	78	Discussion & Recommended Action (in accordance with CAR 2012)

Management Action				
	No action required. Inspect at regular intervals and consider labelling if not already labelled				
	Additional Comments				
Asbestos found in black adhesive only - Grey screed and beige adhesive are none asbestos					
Who can work with / remove this material	Non-Licensed Materials	Recommended re-inspection in:	12 months
